2001 Sea Ray 270 Sundancer

"Infinity"

Report of Marine Survey

Conducted by
Eric Dickerson, SAMS®, SA®

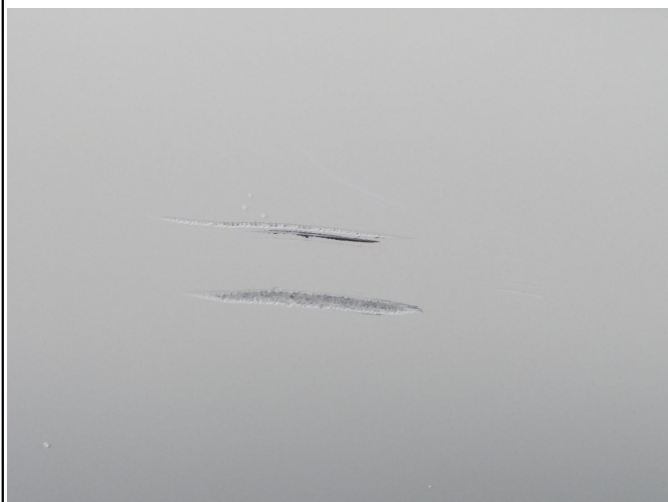
The port topsides has two (2) gouges, approximately three (3) inches each, on the amidships area. Owner states that he will repair these two (2) gouges. The black boot stripe is worn along a majority of the bottom edge throughout and two (2) spots, on the port side, are worn the for most of the thickness of the stripe. The gelcoat on the starboard side sheer line, located in the area below port lights, is dull for an estimated area of two (2) feet. Owner states that this was due to the removal of a decal and not a repair.

Port topsides gelcoat gouges

Follow up with owner on the repair of the two (2) gouges to the gelcoat on the port side. Consideration should be given to wax and buff the dull area on the starboard side and to repair boot stripe for aesthetic purposes when convenient.

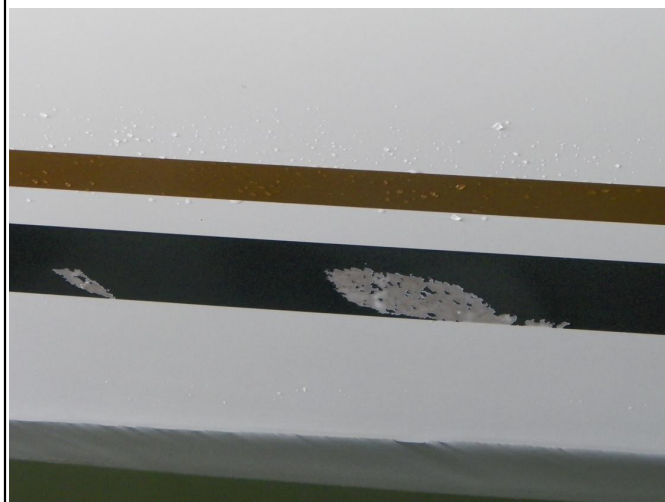
Port topsides boot stripe worn

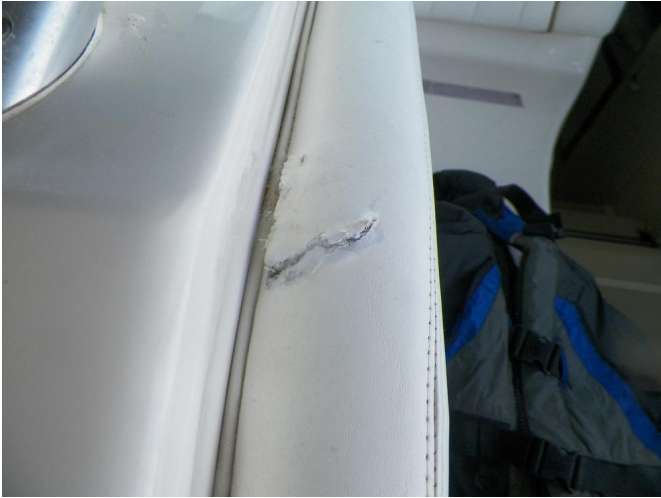
Torn cushion sun lounger

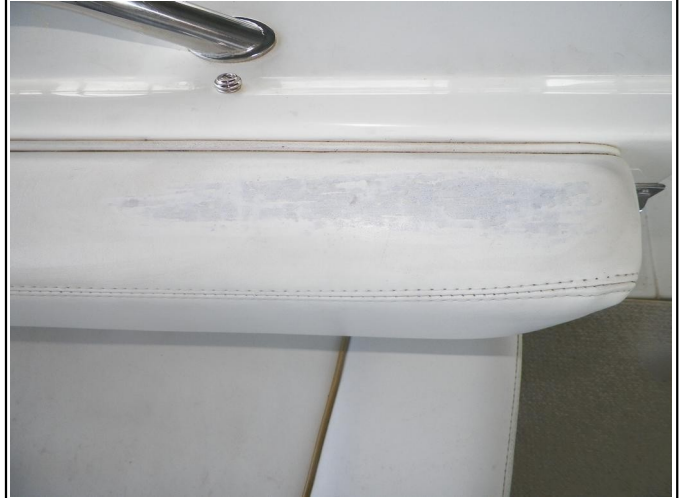
- * COCKPIT: [C5] Aft cockpit with port side sun lounger, aft facing seat, table, and aft bench seat. The seating is white vinyl cushions with gold piping. The back cushion for the aft bench seat has a large area of discoloration. The coaming cushion for the port side sun lounger has a large tear in the vinyl. The bottom cushion for the port sun lounger was not onboard, owner stated that the cushion was at the upholstery shop for repair. Storage is provided by side panels and molded FRP storage bases under the aft removable cushions. The Main DC breaker panel and battery switch is located on the port side. A transom shower is located on the port side and appears in good condition, not tested due to no water in tank. Cup holders are installed at helm area and cockpit area. Grab rails are strategically located in helm and cockpit area, well secured. Indirect lighting is operable. The sole is FRP with non-skid covered with snap in carpet, carpet is in fair condition. The cockpit sole is also the hatch for the engine compartment, serviceable (pneumatic cylinder assisted), and is self bailing. Transom door allows access to and from cockpit from swim platform and is well secured and aligned.

Discoloration aft bench cushion

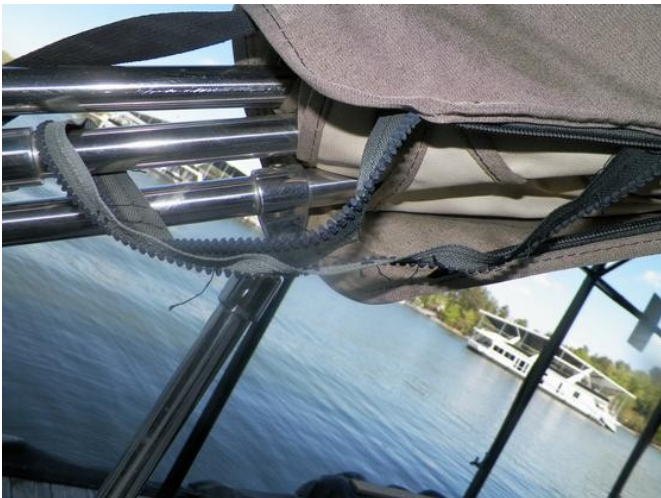
- * BIMINI/COVERS: [C6] Two (2) tan canvas type material with stainless steel tubular support structure. Each bimini retracted and covered at time of survey. Each bimini not fully inspected, cover was unzipped only. The forward bimini's zipper is torn. The rear bimini appears serviceable. A cockpit cover sighted in the transom locker, condition not inspected. What appears to be a camper package sighted beneath the helm seat in the storage locker, not inspected. Support structure is serviceable.

Torn zipper forward bimini

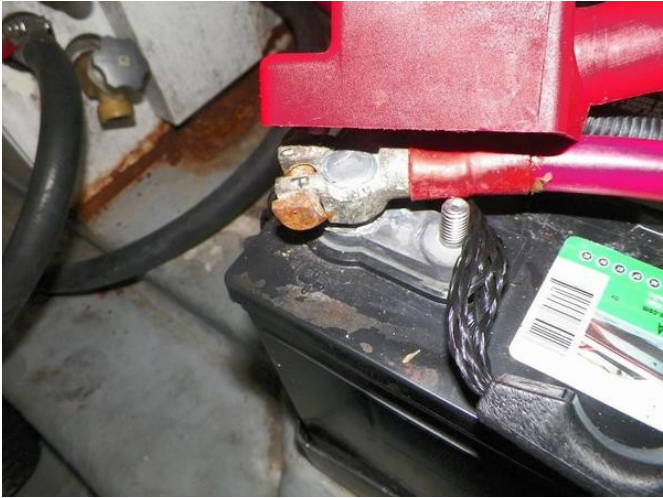
* BATTERIES: [B4] Two (2) lead acid Interstate cranking batteries. CCA: 800 & MCA: 1000. Batteries are not secured and terminal protection covers are loose. Corrosion sighted on terminal connectors.

Terminal protection loose and corrosion on terminal

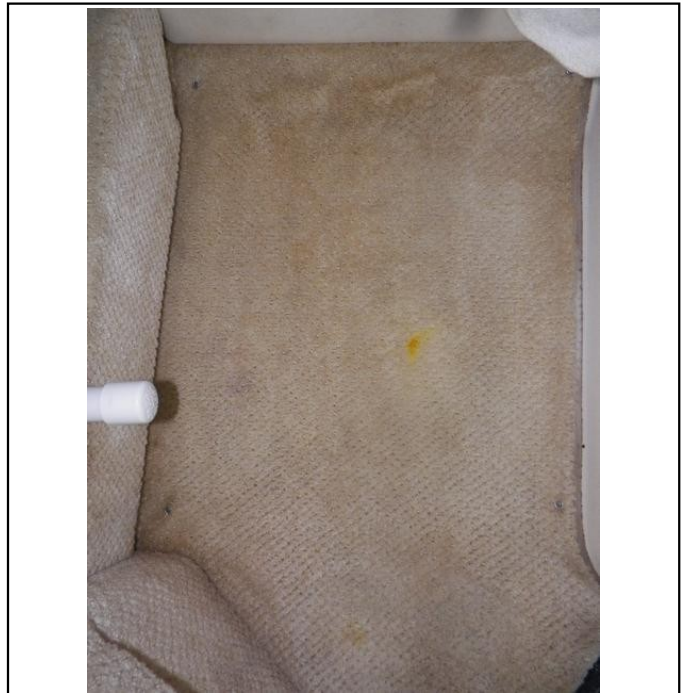
- * FLOOR: [C10] Sole is FRP and covered with carpet. Carpet is loose (unglued from sole) and stained.

Carpet main salon area

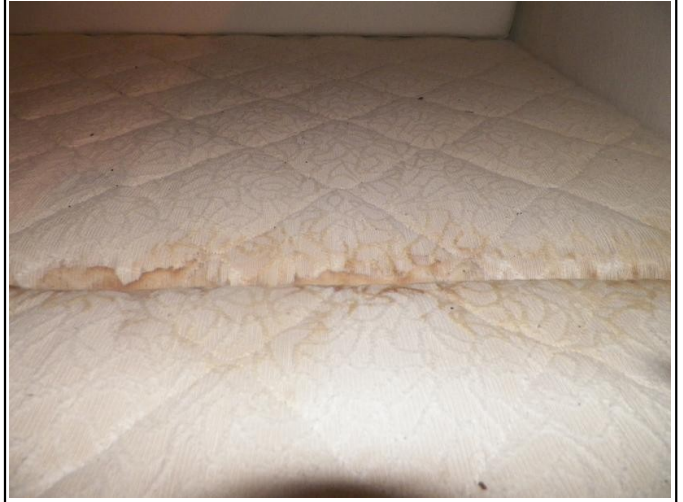
- * WATER INTRUSION SIGNS: [C9] Mid-cabin mattresses has water stains and beneath the mattresses is wet. Owner states this was caused by having the mattresses cleaned. No water intrusion signs sighted due to leaks.

Stained mattresses mid-cabin

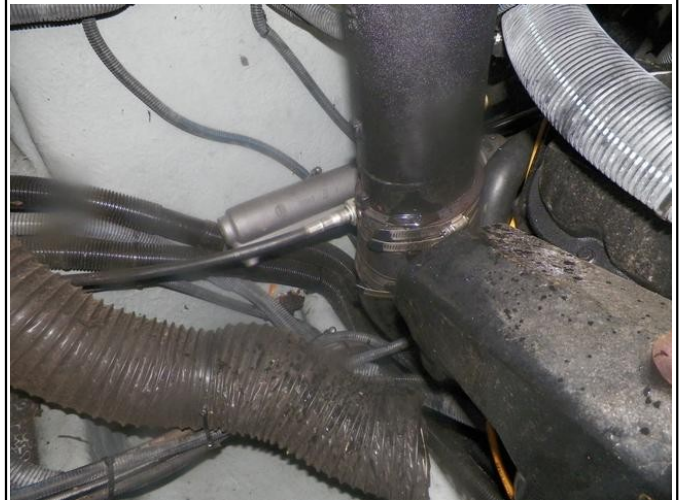
- * EXHAUST SYSTEM: [A1, C14] Underwater wet exhaust. Hose to pipe joints are double clamped on port and starboard side of engine. The starboard exhaust is leaking at the vertical hose to pipe connection. Owner states that he will have repaired. Minor corrosion stains sighted on exhaust manifolds/risers.

Starboard Exhaust Leak

FINDINGS	RECOMMENDATIONS
A.1 (PAGE 7) EXHAUST SYSTEM: The starboard exhaust riser is leaking at the vertical hose to pipe connection.	Follow up with owner and Do Not operate vessel until this leak is proven repaired.
A.2 (PAGE 13) NUMBER OF THROWABLE PFD'S: A Type IV-USCG approved throwable device not sighted on vessel	Equip vessel with a Type IV-USCG approved throwable and mount on the bridge deck/cockpit to be immediately available. Per CFR 33, Sec. 175.15 (b) and Sec 175.19 (b).
A.3 (PAGE 13) VISUAL DISTRESS SIGNALS: Visual distress signals not sighted on vessel.	Vessels operating in Coastal Waters, the Great Lakes, and US boats on the high seas must comply with USCG regulations for Visual Distress Signals, per 33 CFR Sec. 175.110 & Table 175.130.
A.4 (PAGE 13) FUME SNIFFER ALARM SYSTEMS: The carbon monoxide detector is not functioning properly.	Follow up with owner on installation of a new carbon monoxide detector. Do not operate vessel until a working carbon monoxide detector is installed and tested.

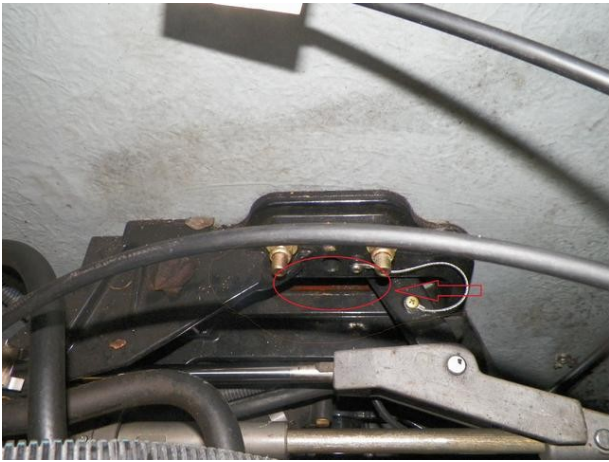
* TRANSOM ASSEMBLY: [B3] A small amount of water and surface corrosion sighted on the interior of the assembly.

transom assembly wet/corrosion

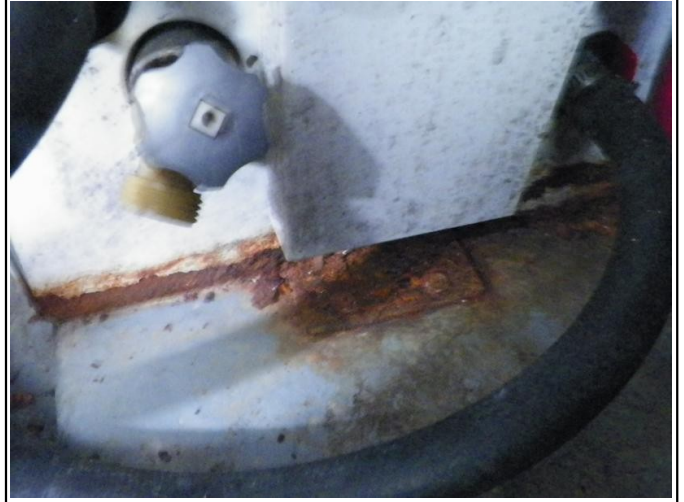
* TYPE: [C16] 120 volt AC electric marine grade water heater. Mfg: Atwood. Model #: EHM-6-SM. Capacity: six (6) gallons. The unit is corroded at the bottom. Not tested due to no water in tank.

Hot water tank corroding at bottom

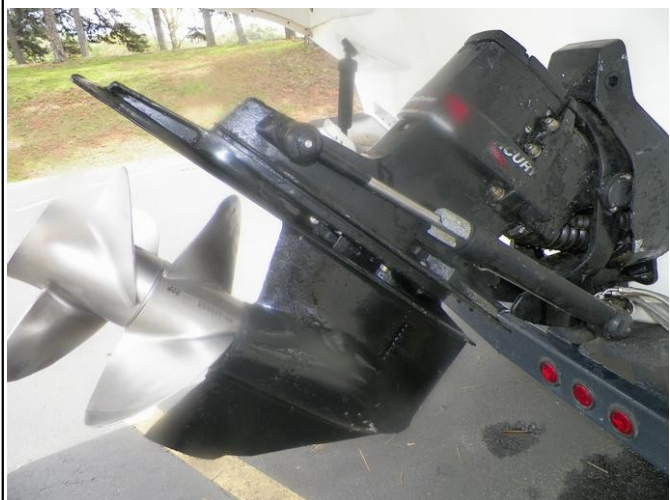
* OUTDRIVE: [C20] Pitting from corrosion sighted on areas of outdrive. The corrosion has been cleaned and painted. Rust/corrosion sighted on exterior transom assembly. Anodes are due for renewal. Lines and fittings appear serviceable, no leaks sighted. Drive operated up and down and responded to steering controls. Oil screw removed and lubrication is at normal level and no signs of water intrusion. Serviceable.

Outdrive unit

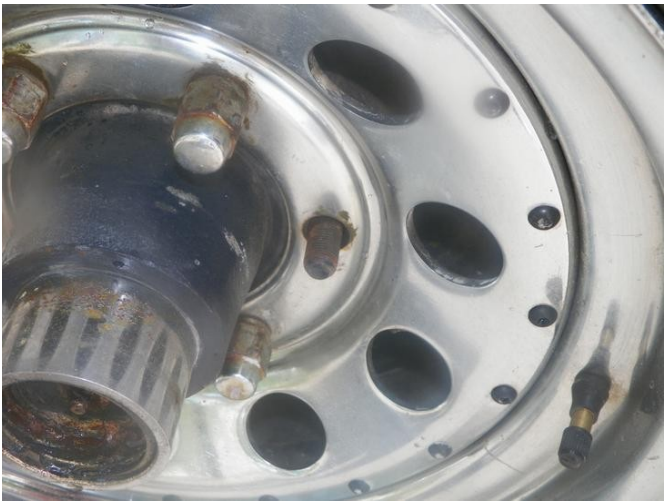
Tire missing lug nut and bearing grease cap

FINDINGS	RECOMMENDATIONS
B.2 (PAGE 6) BOAT TRAILER: The port third tire and starboard first tire are missing lug nuts. The starboard first tire is missing bearing grease cap.	Install lug nuts and bearing grease cap prior to pulling the trailer on public roads.
B.3 (PAGE 8) TRANSOM ASSEMBLY: A small amount of water and surface corrosion sighted on the interior of the transom assembly.	Dry, clean, and monitor. If persists, have a qualified marine mechanic inspect the transom assembly seals and bellows for water tight integrity.
B.4 (PAGE 8) BATTERIES: Batteries are not secured and terminal protection covers are loose and not protecting connections. Corrosion sighted on terminal connectors.	Re-install or replace battery straps/brackets. Repair or renew terminal protectors. ABYC E-10, 10.7 voluntary standards. Clean terminals and apply a corrosion protector/inhibitor.
B.5 (PAGE 10) ANTENNAS: VHF antenna is cracked at base and weathered. Owner has new antenna to install.	Follow up with owner on installation of new antenna.

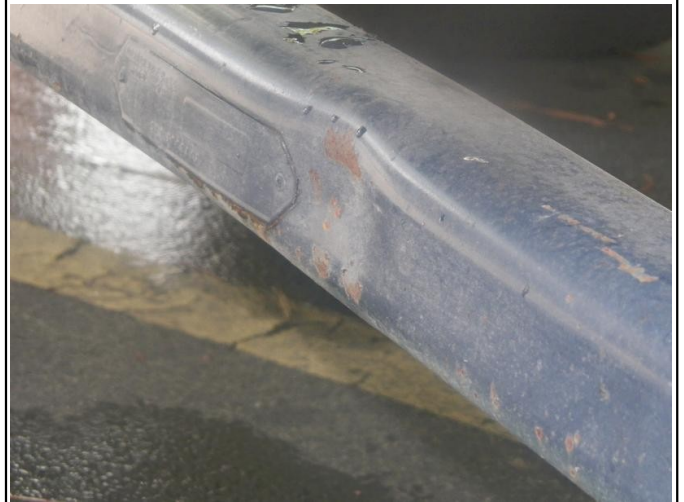
This is a three axle, metal framed with cross members, and powder coated trailer. The powder coating is worn in small areas throughout trailer exhibiting surface rust/corrosion, appears to be structurally sound. Surface rust/corrosion sighted on safety chain, coupler latch, and winch area. The winch and coupler appear serviceable. The jack leg is welded to frame and appears serviceable. Fenders and steps are in good condition. Four (4) bunks covered with carpet support the vessel and appear serviceable (one bolt from bunk was removed by owner due to being loose and scratching bottom of boat during loading and unloading of vessel). Bow roller and support appear in good condition. The port third tire and starboard first tire are missing lug nuts. The starboard first tire is missing bearing grease cap. The trailer is equipped with a spare tire holder, no spare tire (Note: Recommend a spare tire of correct size is mounted on the trailer). Tire and wheels appear serviceable (Note: Recommend tires are checked for proper inflation prior to pulling). The lights and electrical braking system appear serviceable (Note: Test when hooked to trailer prior to pulling). The first axle has a dent in outer metal cover, does not appear to affect the axle.

Axle cover dented
